MML TR-80-17-c

BONDABILITY OF TI ADHERENDS

Martin Marietta Laboratories
1450 South Rolling Road
Baltimore, Maryland 21227

Final Report 4/1/79 - 3/31/80

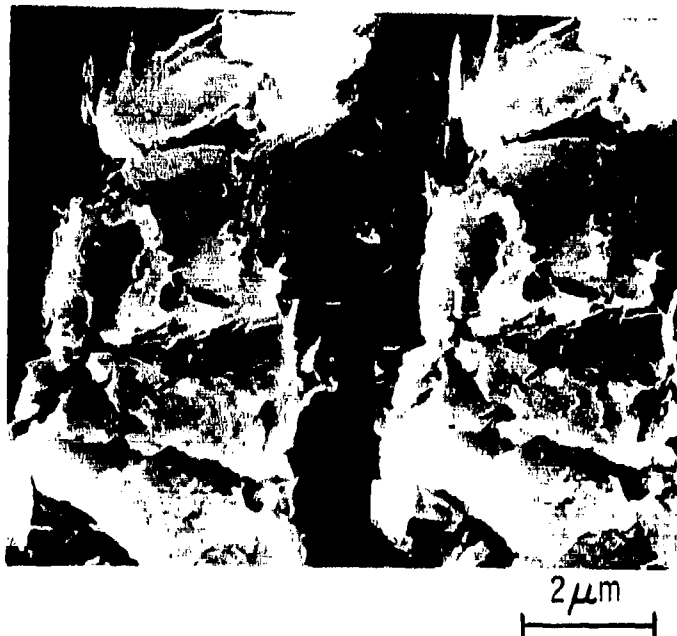
Figure 7. Stereo electron micrograph of the adherend formed by the dry hone PASA JELL 107 treatment.

The DP surface, shown in Figure 7, is quite different from the other surfaces in this group. Apparently, dry abrasion of the Ti surface results in a heavily deformed and fragmented surface with a great deal of macroscopic roughness. This treatment also spreads Al_2O_3 over the surface. The

oxide resulting from this treatment is roughly 100-200 Å thick, the large uncertainty due in part to the roughness of the surface and the presence of embedded Al_2O_3 .

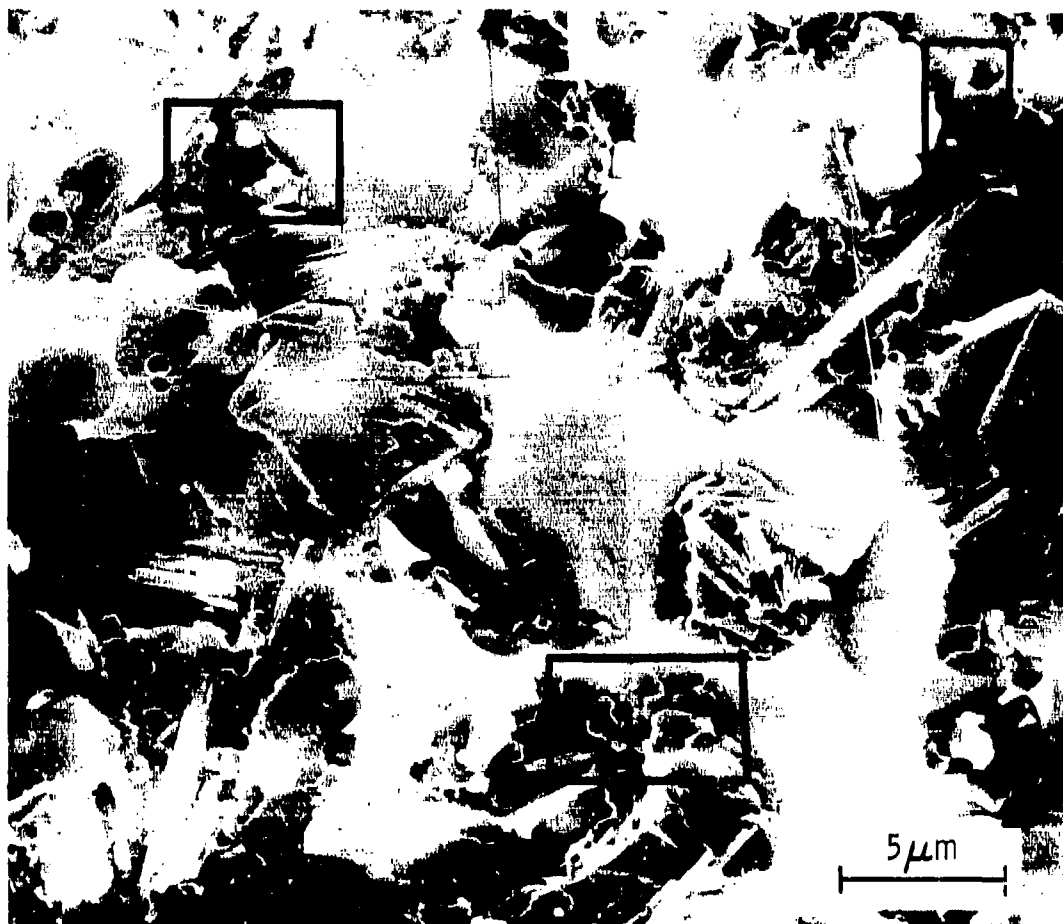
Figure 18. A collage of electron micrographs of the Ti side of a failed TU-treated Ti wedge test panel. A thin layer of primer covers the surface. The upper two boxed areas point to regions where Fe particles were found. The area within the lower rectangle was clearly bonded to a cluster of Fe particles.

The improved performance with the TU and LP adherends was probably due to their greater micro-roughness, compared to the DA surface. Actually, since the TU and LP adherends were so similar in morphology, it was somewhat surprising to find that the TU adherend exhibited some adhesive failure (as judged by the unaided eye), while the LP adherend did not. However, when we examined the metal side of the TU failure surface with the STEM, we found a thin layer of primer covering the surface (Figure 18), i.e., the failure was actually cohesive.

It should also be noted that Fe particles were found on this surface just as on the prebonded surface. Fe particles were also found on the adhesive side of the failure (Figure 19). The presence of Fe on both sides of the failure surface suggests that failure actually occurred along the line of Fe particles. Thus, we suspect that Fe particles act as stress raisers which localize failure near the Ti adherend. This chemical difference between the TU and LP adherends appears to explain their slightly different failure modes.

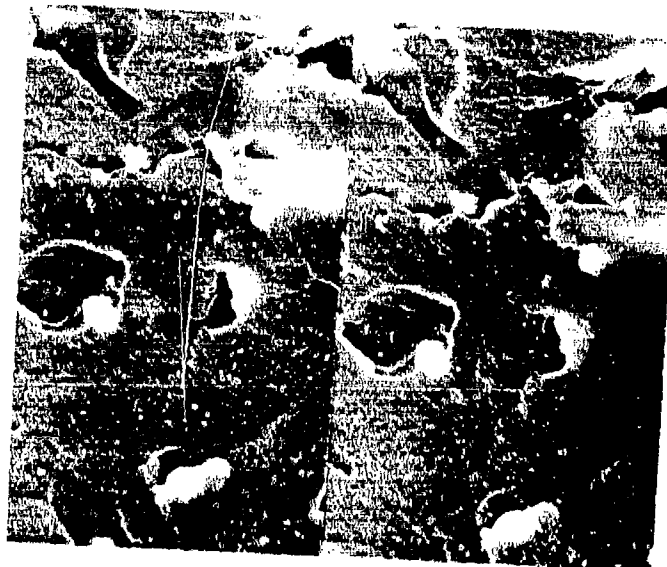
Figure 19. A stereo electron micrograph of a Fe particle embedded in the primer (on the primer side) of a failed TU wedge test panel.
